FLORIDA FISH AND WILDLIFE CONSERVATION COMMISSION DIVISION OF LAW ENFORCEMENT

CAPTIVE WILDLIFE INJURY BITE ESCAPE FORM

County: Orange Incident: FWNE15OFF009829 Type: ESCAPE IBE#: 15-030
 Reporting Investigator: R. K. Brown, #0028 Incident Date: 09/01/2015
 Complaint Officer(s): Invs. R. K. Brown, #0028, S. McDaniel, Date Reported: 09/02/2015
D. Saunders Report Date: 09/04/2015

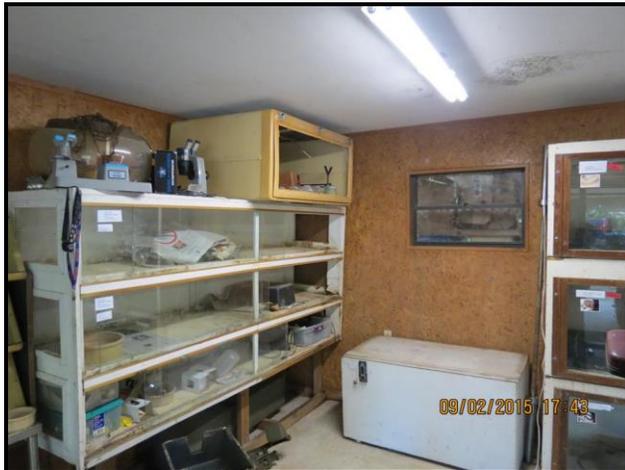
Male cobra was in the far middle cage

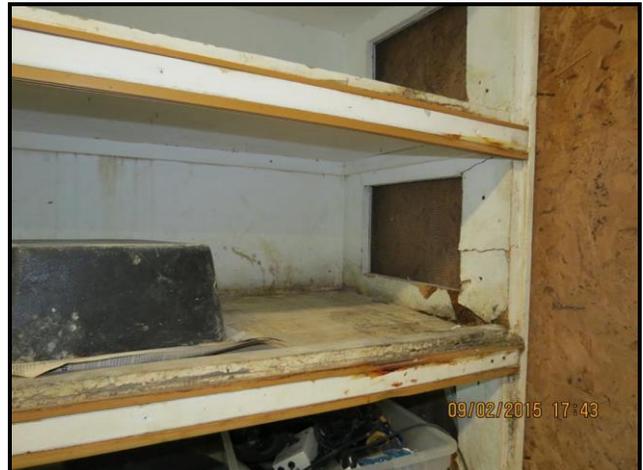
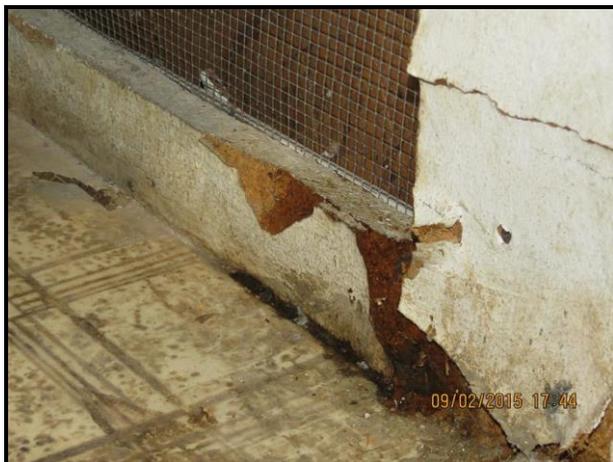
2. The cage has been in use for more than 14 years.
3. There are locked, glass doors on the front.
4. There are hardware-cloth covered side vents. The hardware-cloth is stapled and “pinched” within a wooden frame to the cage.
5. Water damaged the Melamine and softened the material so that the cobra was able to push against the screen and cause a break to its attachment to the cage. This part of the cage was pushed up into the corner of the garage and this vent was approximately 1 ½” from the garage’s back wall.

Water damage

Warning # W802155 issued for failure to use approved materials for venomous reptiles.

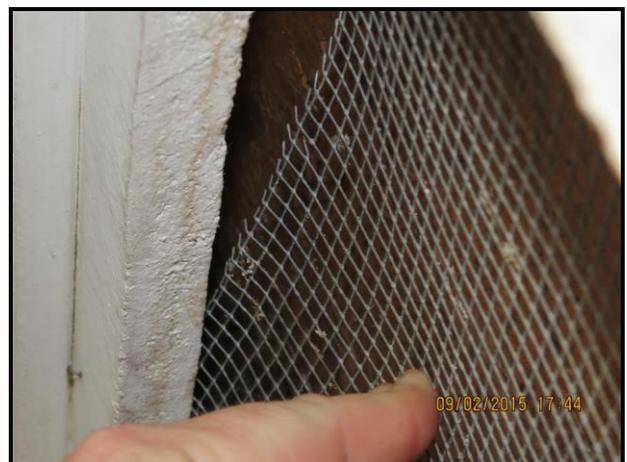
Gap created by cobra
